MICROSCOPIC EXAMINATION OF STEEL

HENRY FAY, Ph. D., D. Sc.

*Professor of Analytical Chemistry, Massachusetts Institute of Technology
Consulting Metallurgist, Watertown Arsenal*

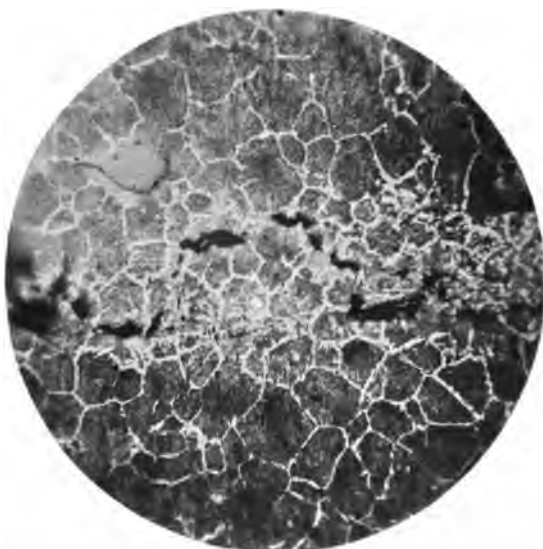
PHOTOGRAPH NO. 53. X50.

Twelve-inch gun. Microstructure showing slag and fissures.

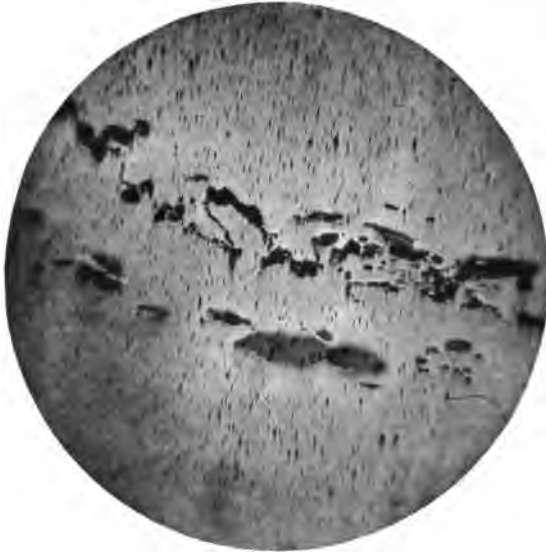
PHOTOGRAPH NO. 54. X50.
Twelve-inch gun. Slag in unetched specimen.

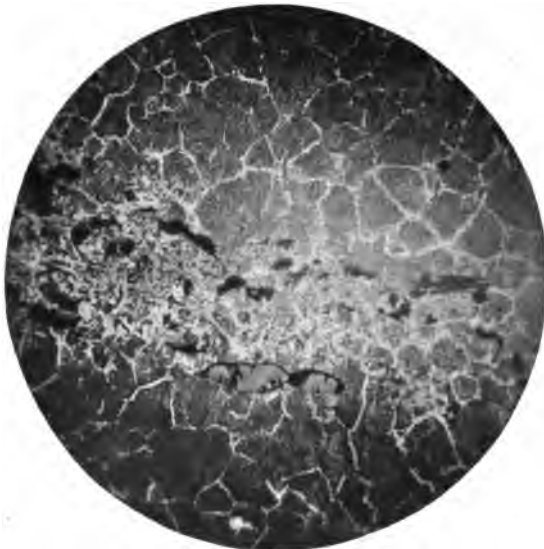
PHOTOGRAPH NO. 55. X50.
Twelve-inch gun. Same area as No. 54, etched with alcoholic nitric acid.
